TAMU Project

**Energy Consumption Data Quality Assurance/Quality
Control Assessment Report for the
Month of October 2016**

**Utility & Energy Services
Division of Administration
Texas A&M University**

November 2016

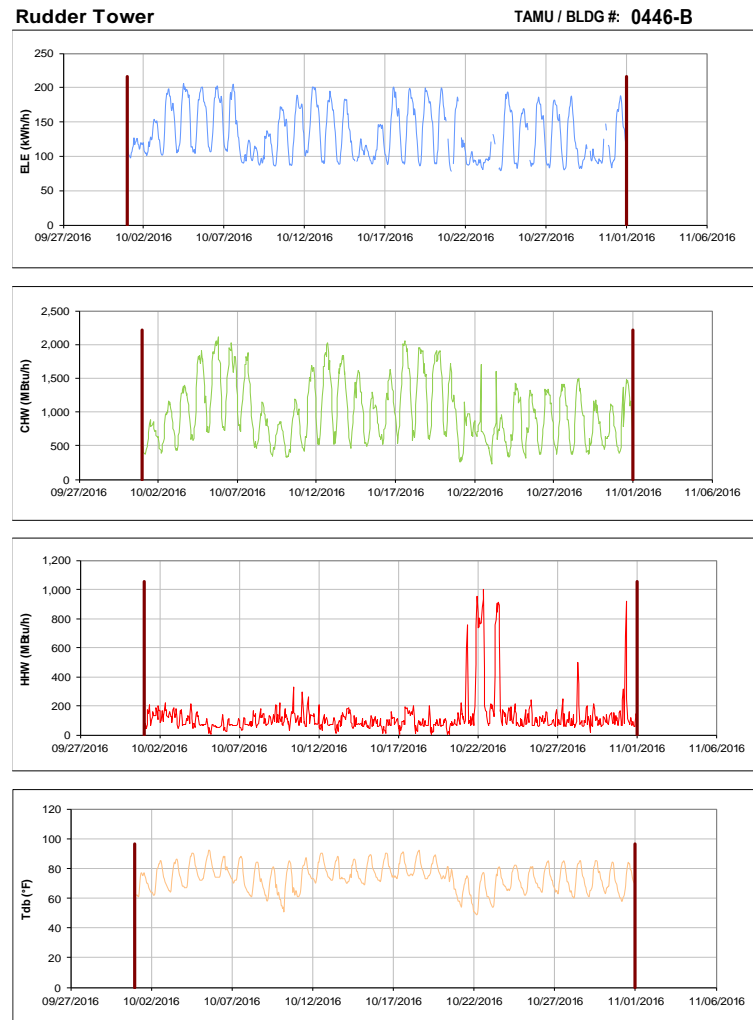
Figure III-69 Hourly Whole Building Electricity, Chilled Water, and Hot Water Consumption for Rudder Tower during the Month of October 2016 and the Corresponding Hourly Outdoor Dry Bulb Temperature for College Station, TX

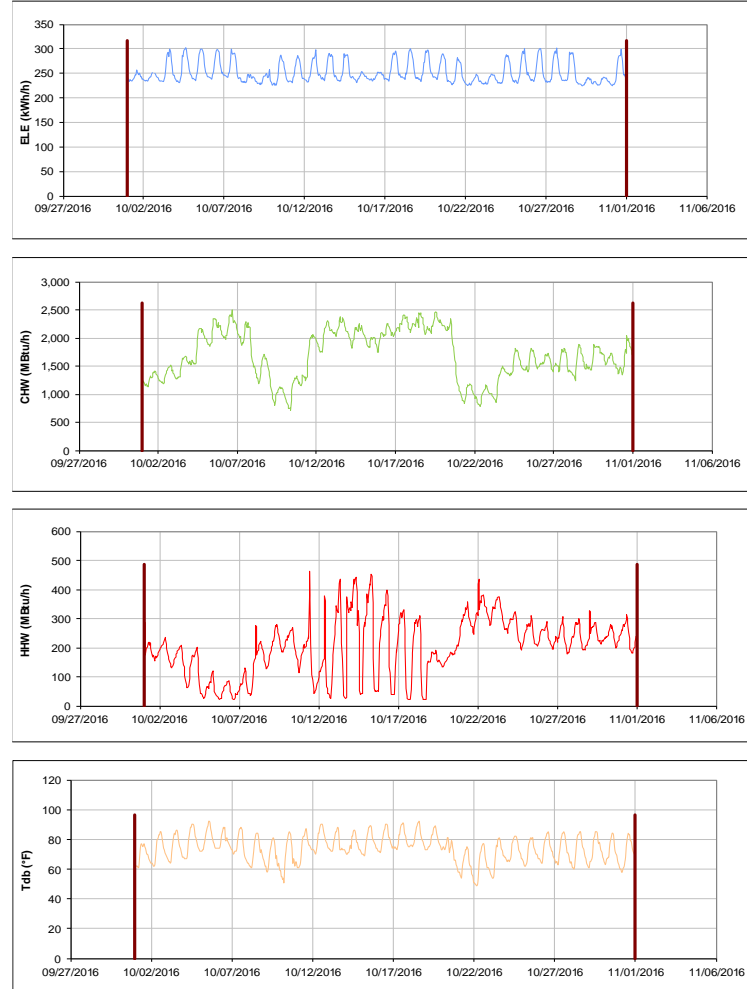
TAMU / BLDG #: 0449

Figure III-71 Hourly Whole Building Electricity, Chilled Water, and Hot Water Consumption for Biological Sciences Building - West during the Month of October 2016 and the Corresponding Hourly Outdoor Dry Bulb Temperature for College Station, TX

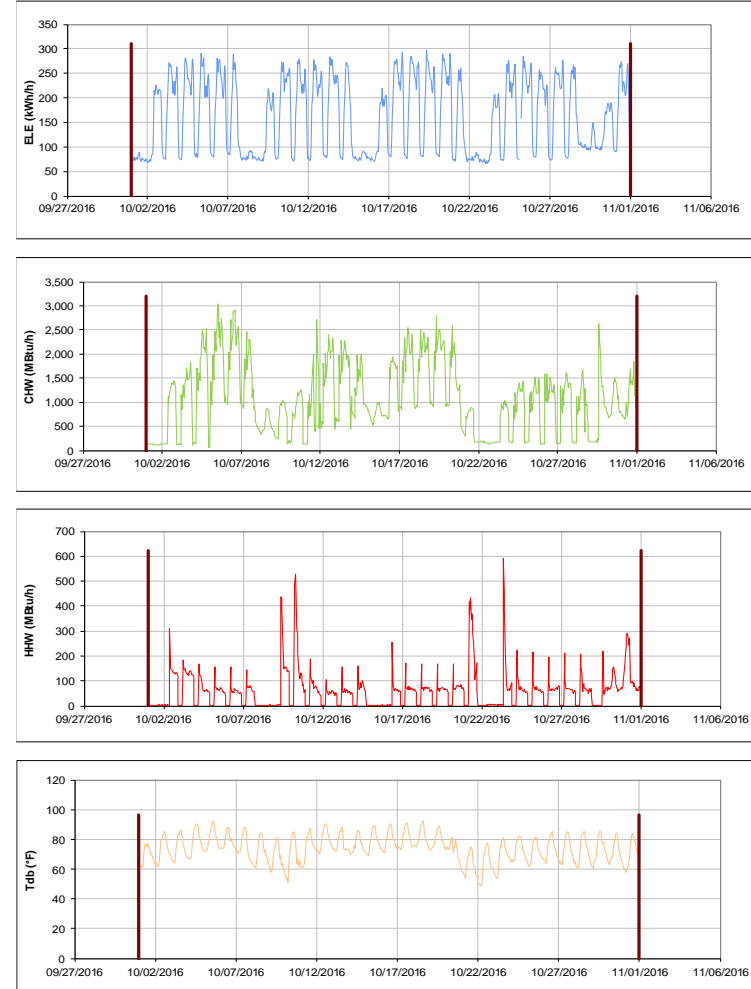
TAMU / BLDG #: 0450

Figure III-72 Hourly Whole Building Electricity, Chilled Water, and Hot Water Consumption for Duncan Dining Hall during the Month of October 2016 and the Corresponding Hourly Outdoor Dry Bulb Temperature for College Station, TX

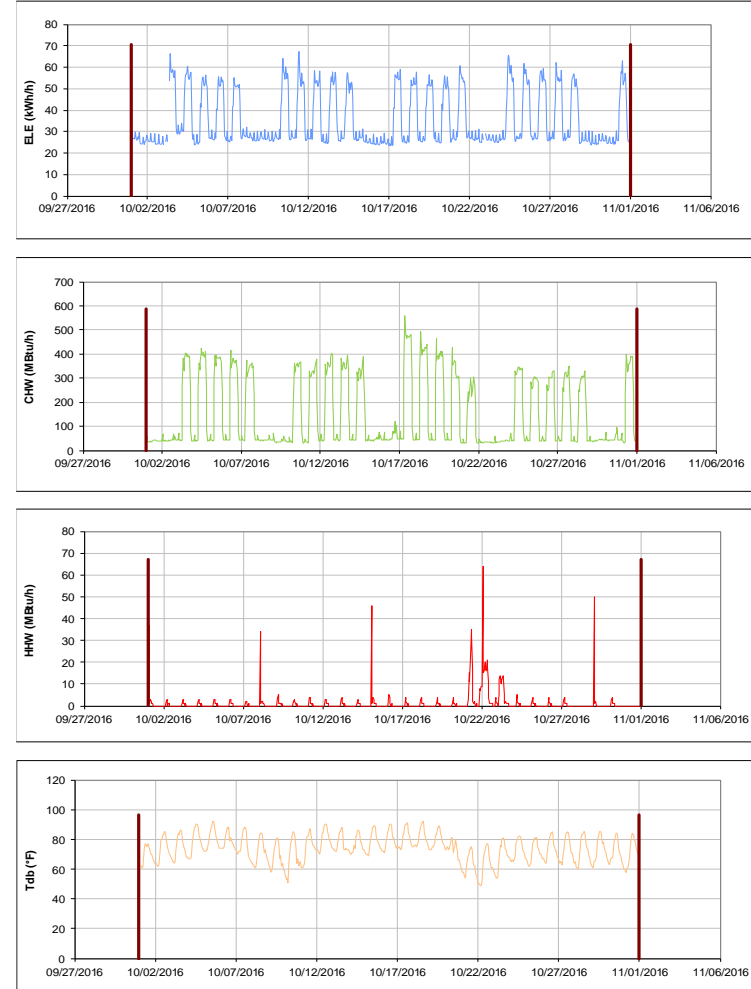
TAMU / BLDG #: 0461

Figure III-76 Hourly Whole Building Electricity, Chilled Water, and Hot Water Consumption for Coke Building during the Month of October 2016 and the Corresponding Hourly Outdoor Dry Bulb Temperature for College Station, TX

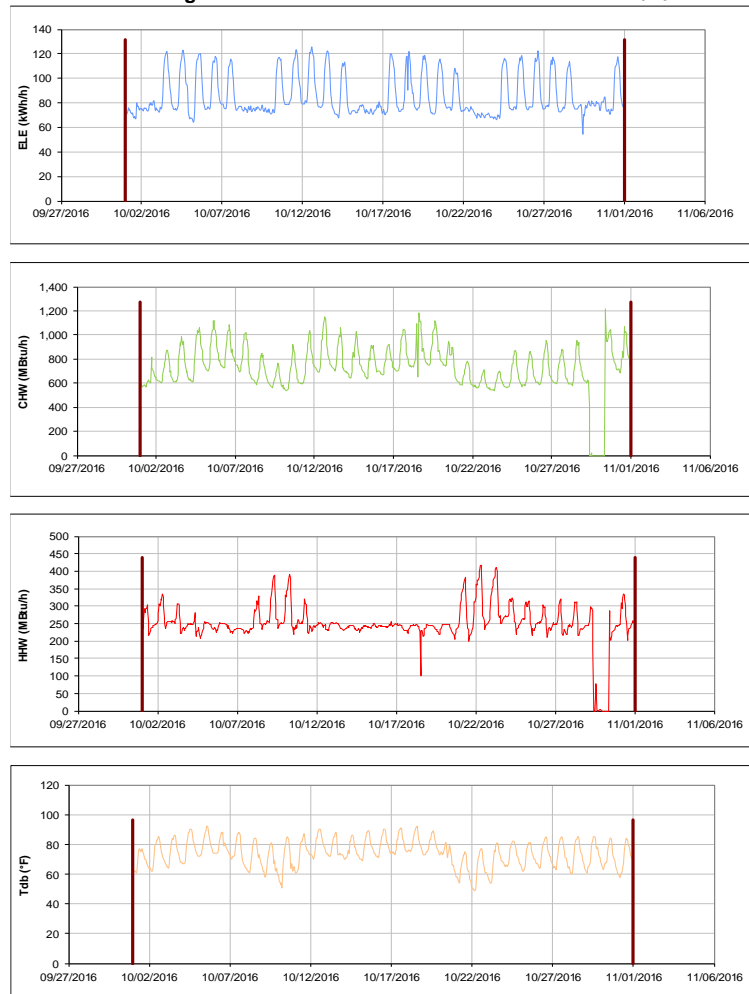
TAMU / BLDG #: 0462

Figure III-77 Hourly Whole Building Electricity, Chilled Water, and Hot Water Consumption for Academic Building during the Month of October 2016 and the Corresponding Hourly Outdoor Dry Bulb Temperature for College Station, TX

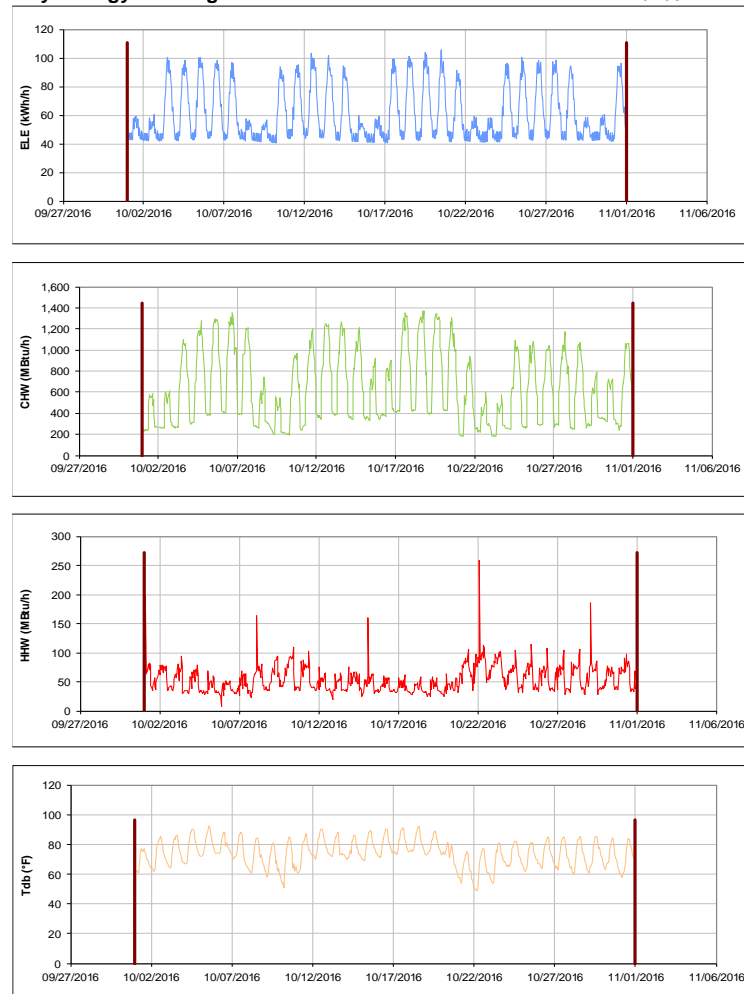
TAMU / BLDG #: 0463

Figure III-78 Hourly Whole Building Electricity, Chilled Water, and Hot Water Consumption for Psychology Building during the Month of October 2016 and the Corresponding Hourly Outdoor Dry Bulb Temperature for College Station, TX

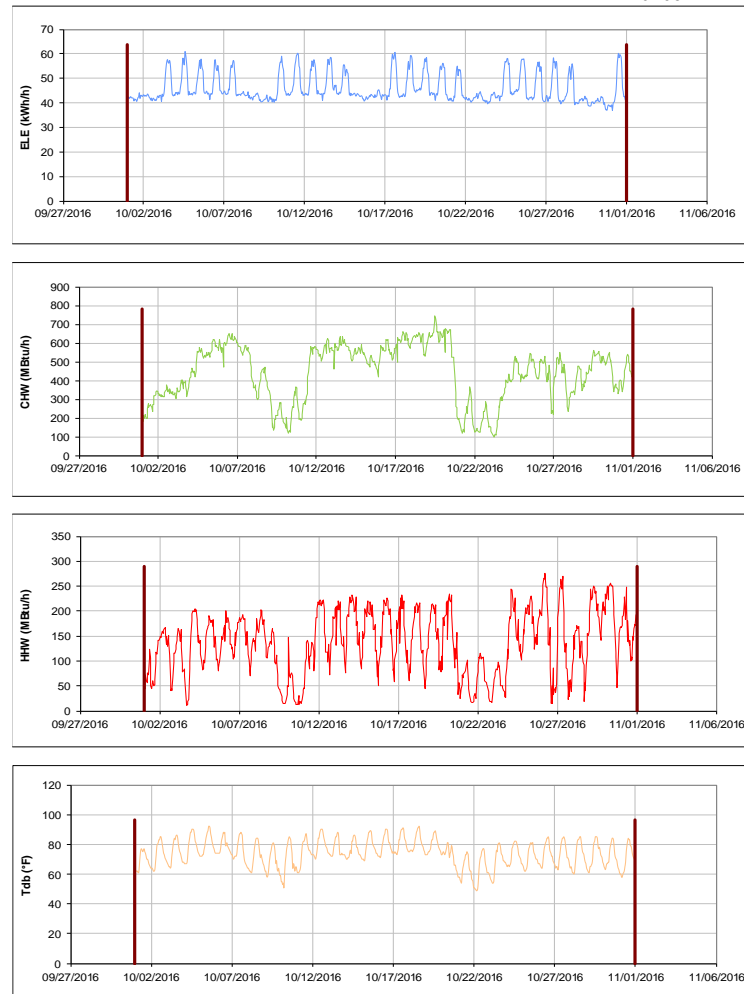
TAMU / BLDG #: 0465

Figure III-80 Hourly Whole Building Electricity, Chilled Water, and Hot Water Consumption for Butler Hall during the Month of October 2016 and the Corresponding Hourly Outdoor Dry Bulb Temperature for College Station, TX

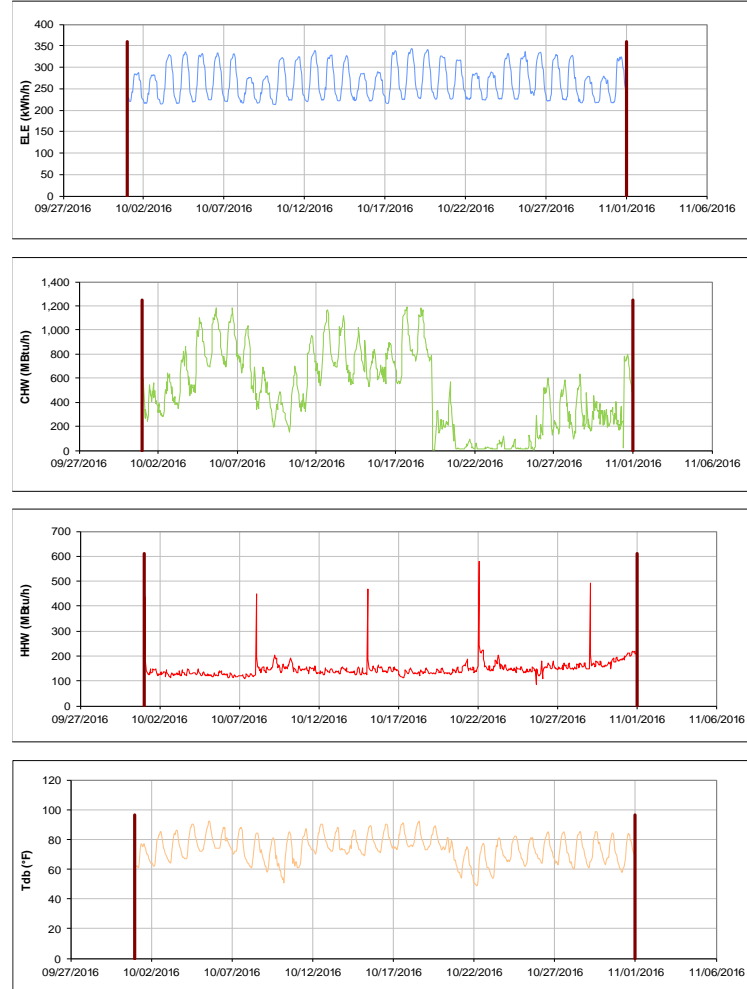
TAMU / BLDG #: 0467

Figure III-81 Hourly Whole Building Electricity, Chilled Water, and Hot Water Consumption for Biological Sciences Building - East during the Month of October 2016 and the Corresponding Hourly Outdoor Dry Bulb Temperature for College Station, TX

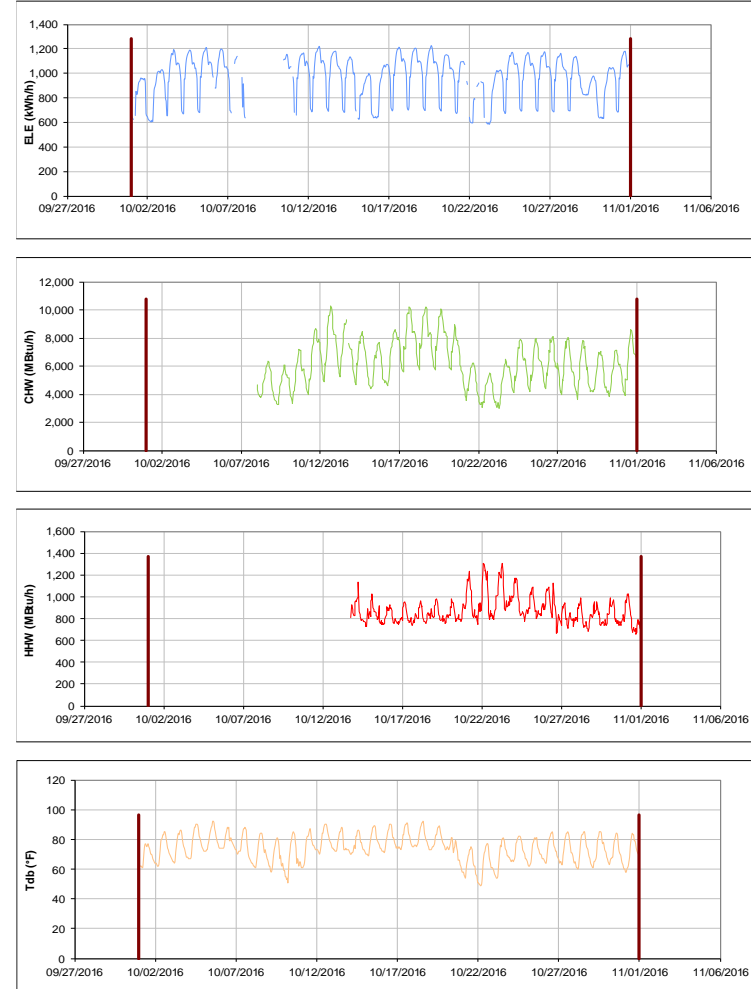
TAMU / BLDG #: 0468

Figure III-82 Hourly Whole Building Electricity, Chilled Water, and Hot Water Consumption for Evans Library during the Month of October 2016 and the Corresponding Hourly Outdoor Dry Bulb Temperature for College Station, TX

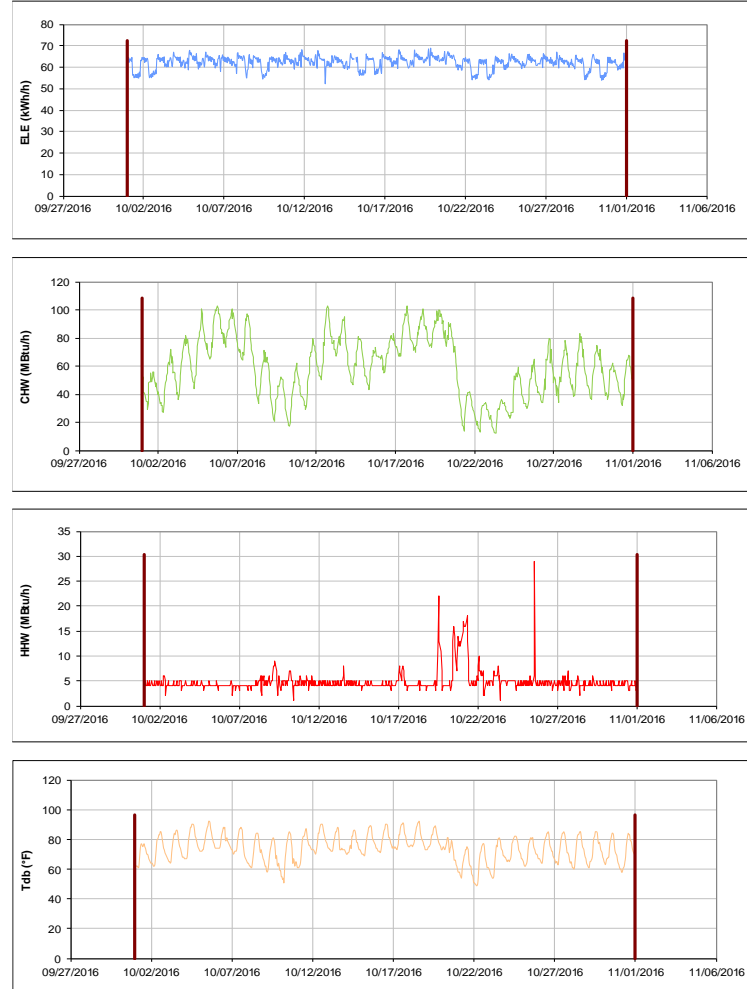
TAMU / BLDG #: 0469

Figure III-83 Hourly Whole Building Electricity, Chilled Water, and Hot Water Consumption for Central Campus Parking Garage during the Month of October 2016 and the Corresponding Hourly Outdoor Dry Bulb Temperature for College Station, TX

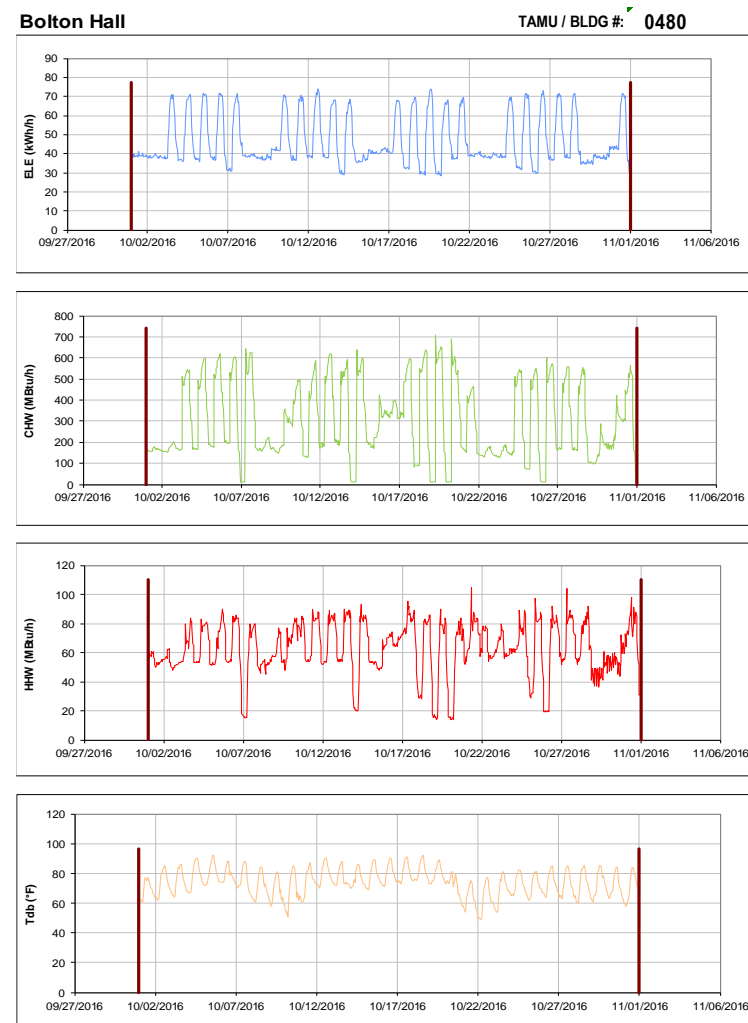
Figure III-92 Hourly Whole Building Electricity, Chilled Water, and Hot Water Consumption for Bolton Hall during the Month of October 2016 and the Corresponding Hourly Outdoor Dry Bulb Temperature for College Station, TX

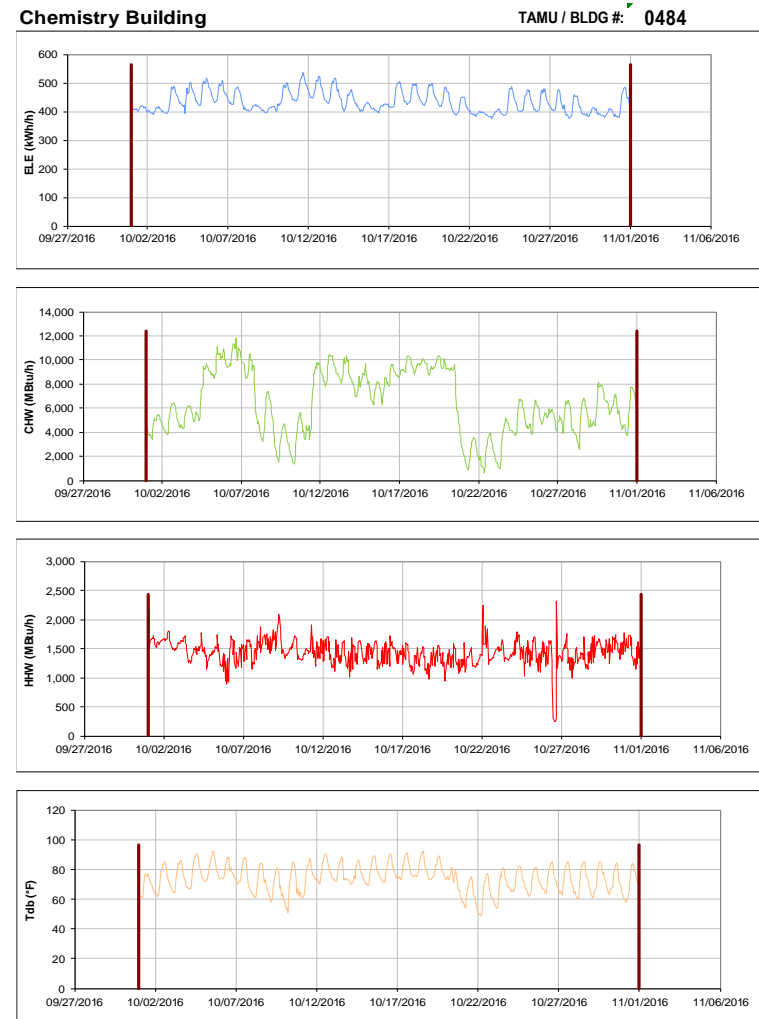
Figure III-96 Hourly Whole Building Electricity, Chilled Water, and Hot Water Consumption for Chemistry Building during the Month of October 2016 and the Corresponding Hourly Outdoor Dry Bulb Temperature for College Station, TX

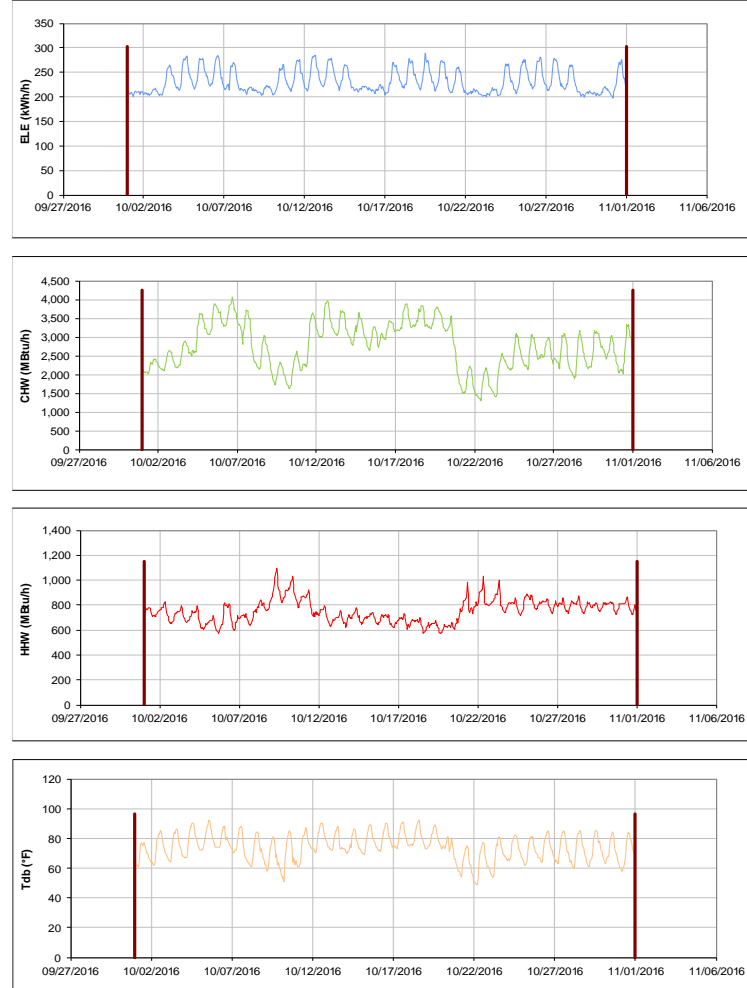
TAMU / BLDG #: 0490

Figure III-97 Hourly Whole Building Electricity, Chilled Water, and Hot Water Consumption for Halbouty Geosciences Building during the Month of October 2016 and the Corresponding Hourly Outdoor Dry Bulb Temperature for College Station, TX

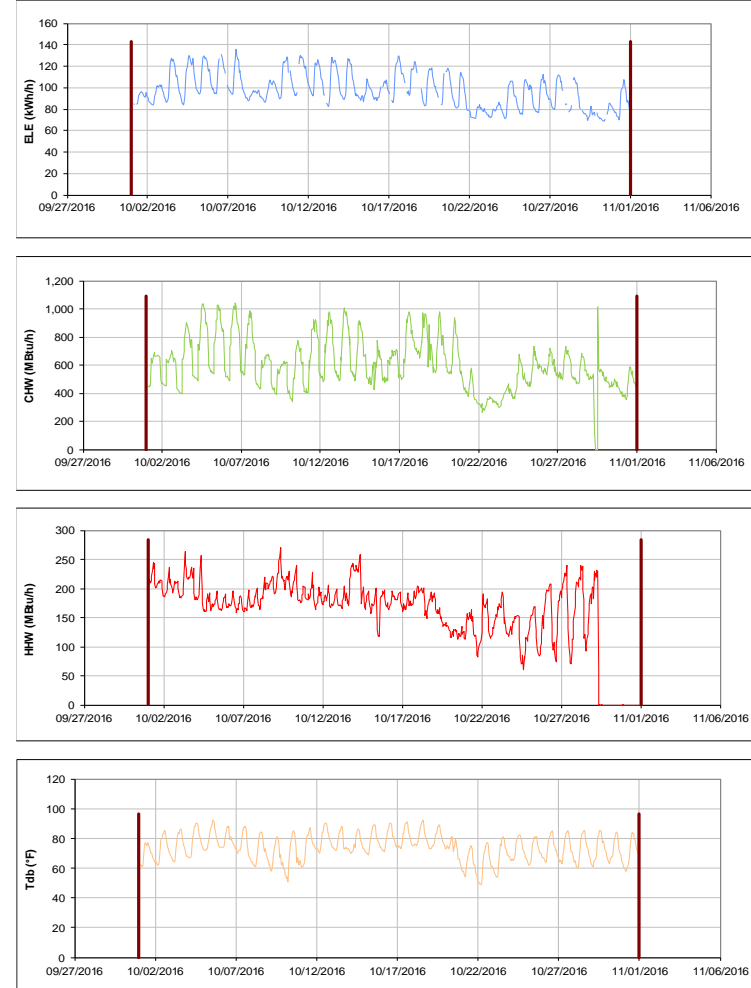
TAMU / BLDG #: 0492

Figure III-98 Hourly Whole Building Electricity, Chilled Water, and Hot Water Consumption for Civil Engineering Building during the Month of October 2016 and the Corresponding Hourly Outdoor Dry Bulb Temperature for College Station, TX

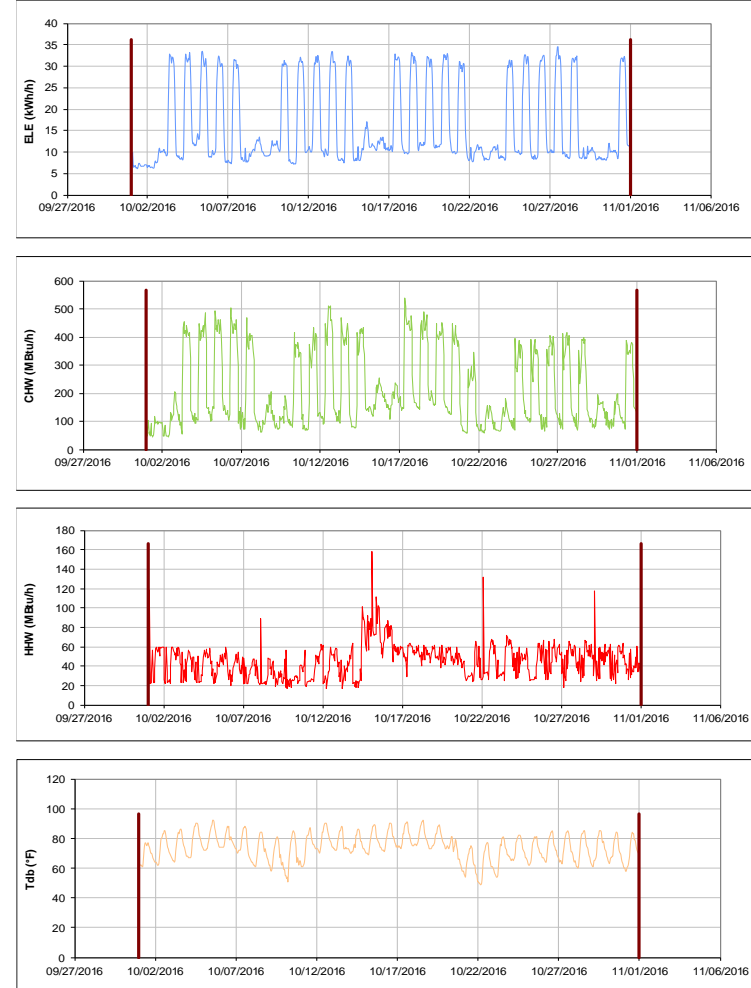
TAMU / BLDG #: 0496

Figure III-100 Hourly Whole Building Electricity, Chilled Water, and Hot Water Consumption for Utilities & Energy Services Central Office during the Month of October 2016 and the Corresponding Hourly Outdoor Dry Bulb Temperature for College Station, TX

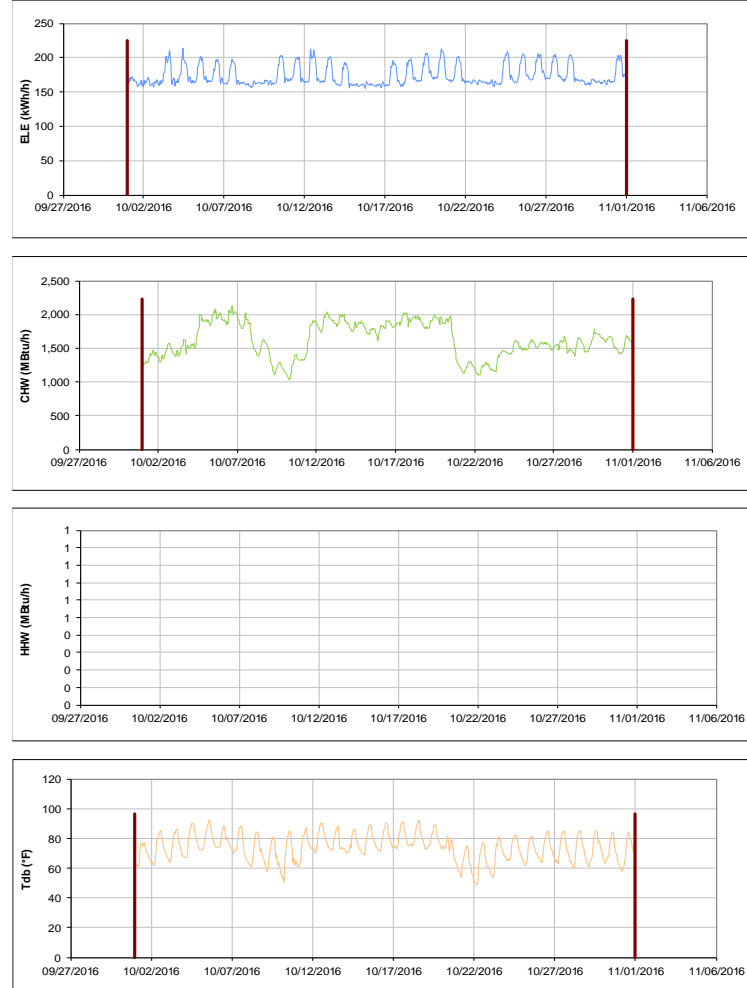
TAMU / BLDG #: 1026

Figure III-105 Hourly Whole Building Electricity, Chilled Water, and Hot Water Consumption for Veterinary Medicine Administration during the Month of October 2016 and the Corresponding Hourly Outdoor Dry Bulb Temperature for College Station, TX

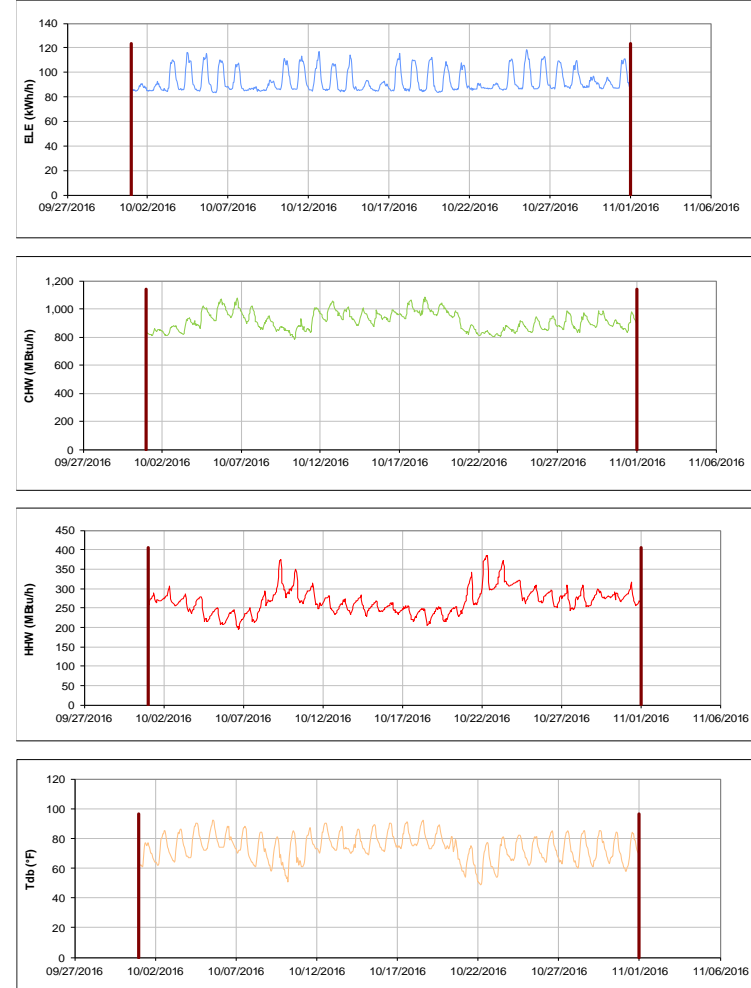
TAMU / BLDG #: 0511

Figure III-106 Hourly Whole Building Electricity, Chilled Water, and Hot Water Consumption for Heep Laboratory Building during the Month of October 2016 and the Corresponding Hourly Outdoor Dry Bulb Temperature for College Station, TX

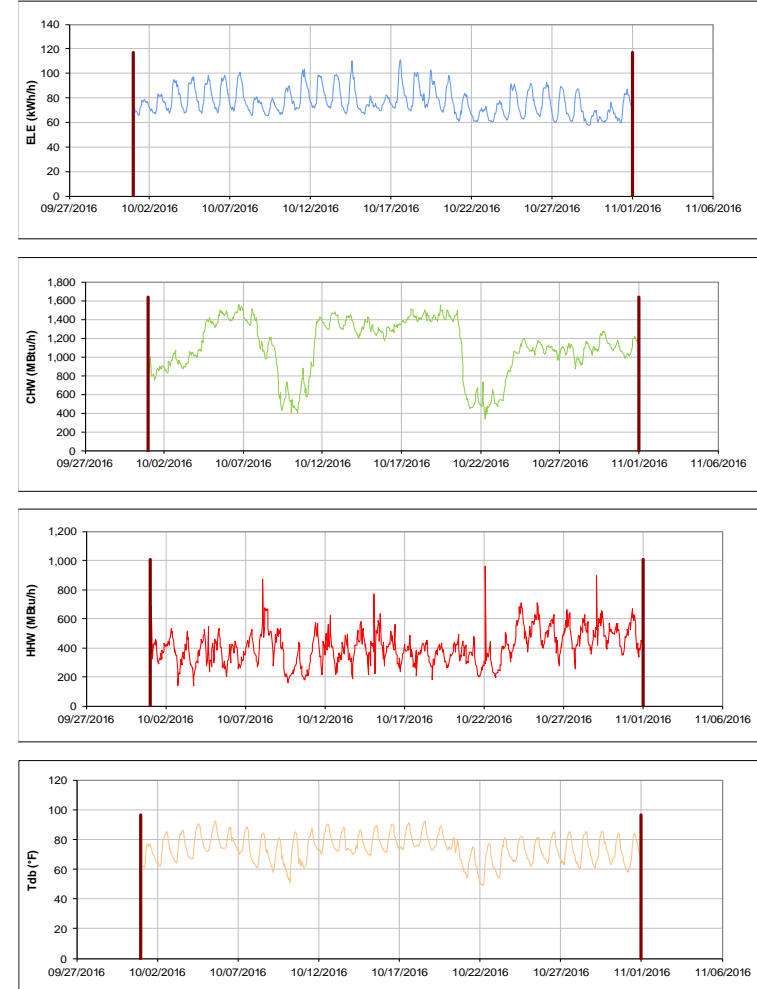
TAMU / BLDG #: 0513

Figure III-108 Hourly Whole Building Electricity, Chilled Water, and Hot Water Consumption for Doherty Building during the Month of October 2016 and the Corresponding Hourly Outdoor Dry Bulb Temperature for College Station, TX

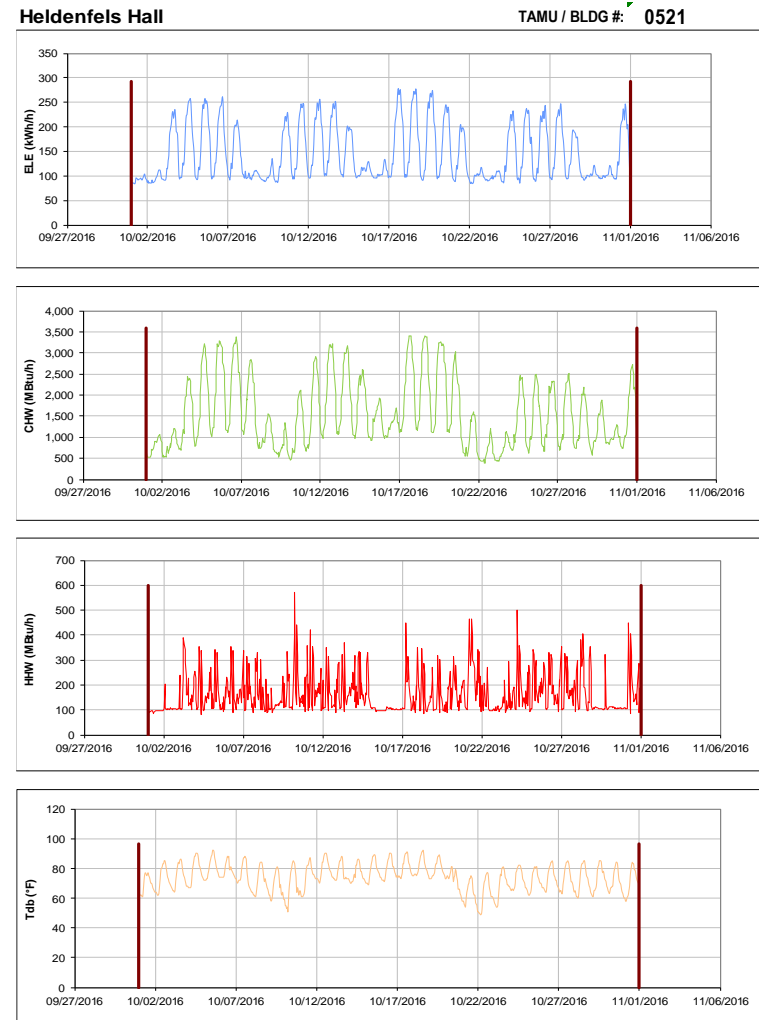
Figure III-112 Hourly Whole Building Electricity, Chilled Water, and Hot Water Consumption for Heldenfels Hall during the Month of October 2016 and the Corresponding Hourly Outdoor Dry Bulb Temperature for College Station, TX

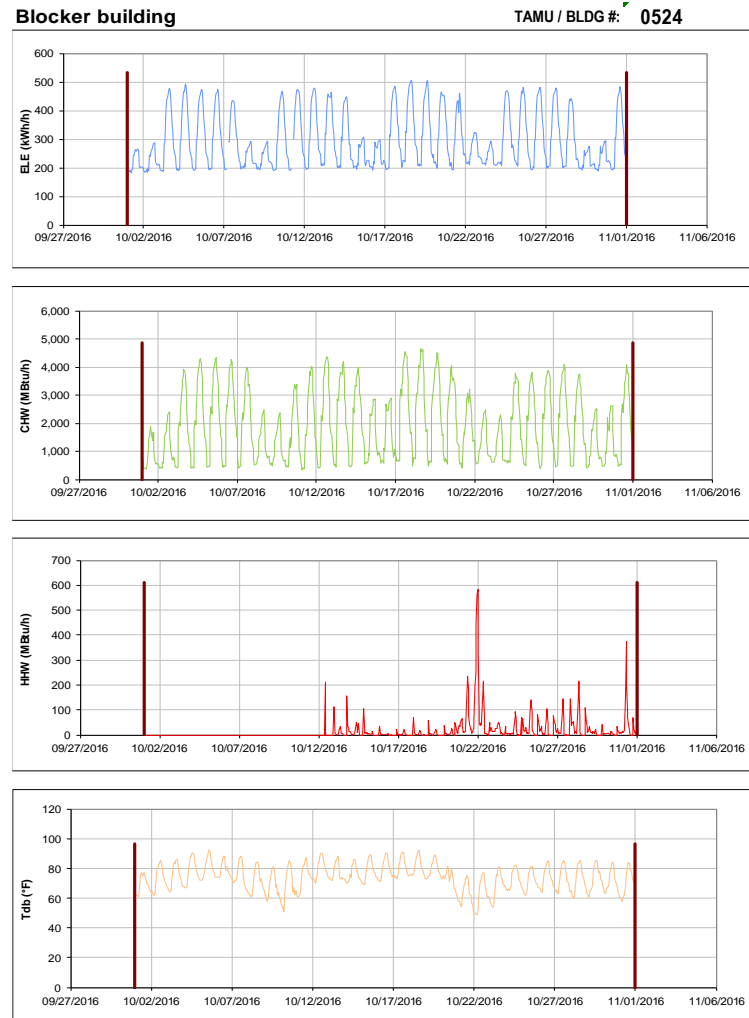
Figure III-113 Hourly Whole Building Electricity, Chilled Water, and Hot Water Consumption for Blocker building during the Month of October 2016 and the Corresponding Hourly Outdoor Dry Bulb Temperature for College Station, TX

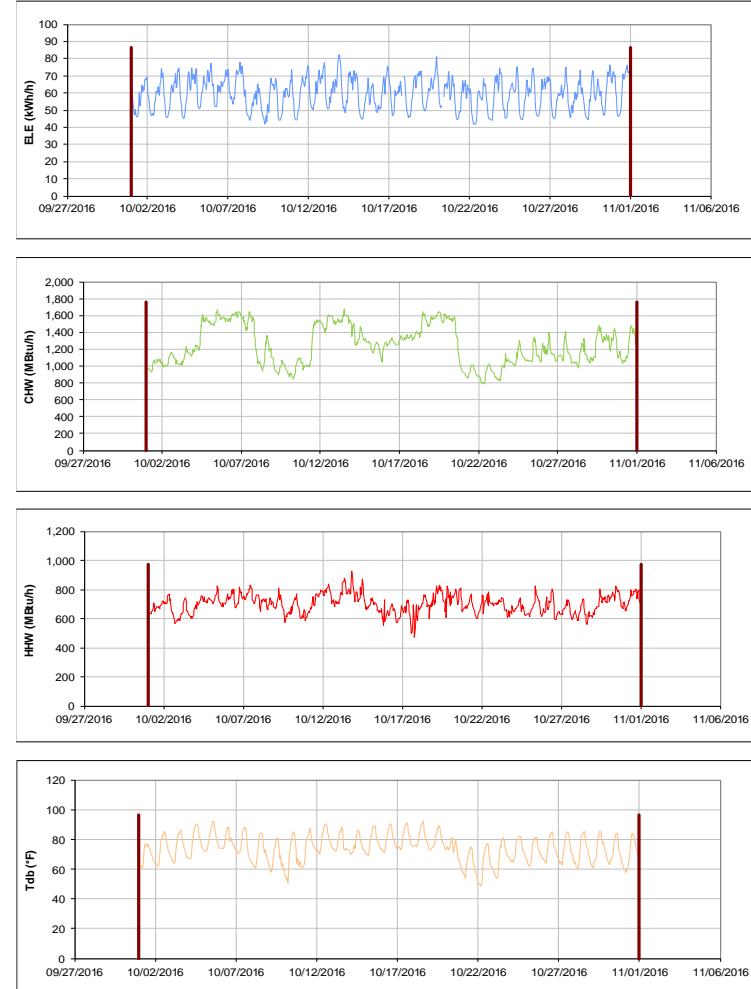
TAMU / BLDG #: 0550

Figure III-116 Hourly Whole Building Electricity, Chilled Water, and Hot Water Consumption for McFadden Residence Hall during the Month of October 2016 and the Corresponding Hourly Outdoor Dry Bulb Temperature for College Station, TX

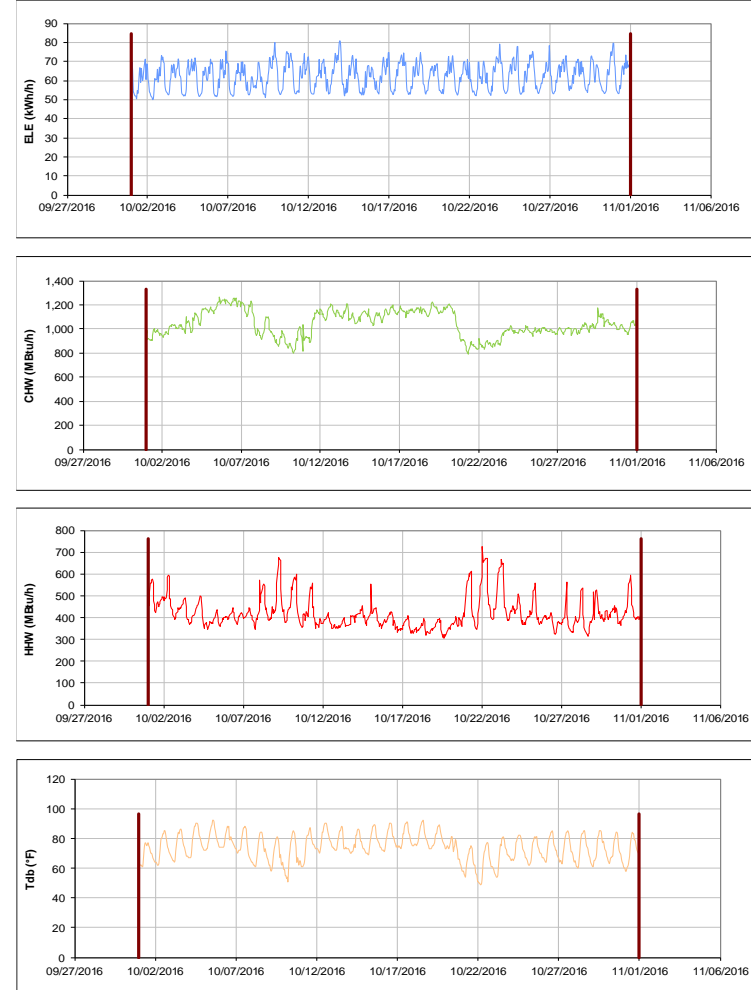
TAMU / BLDG #: 0653

Figure III-118 Hourly Whole Building Electricity, Chilled Water, and Hot Water Consumption for Hobby Residence Hall during the Month of October 2016 and the Corresponding Hourly Outdoor Dry Bulb Temperature for College Station, TX

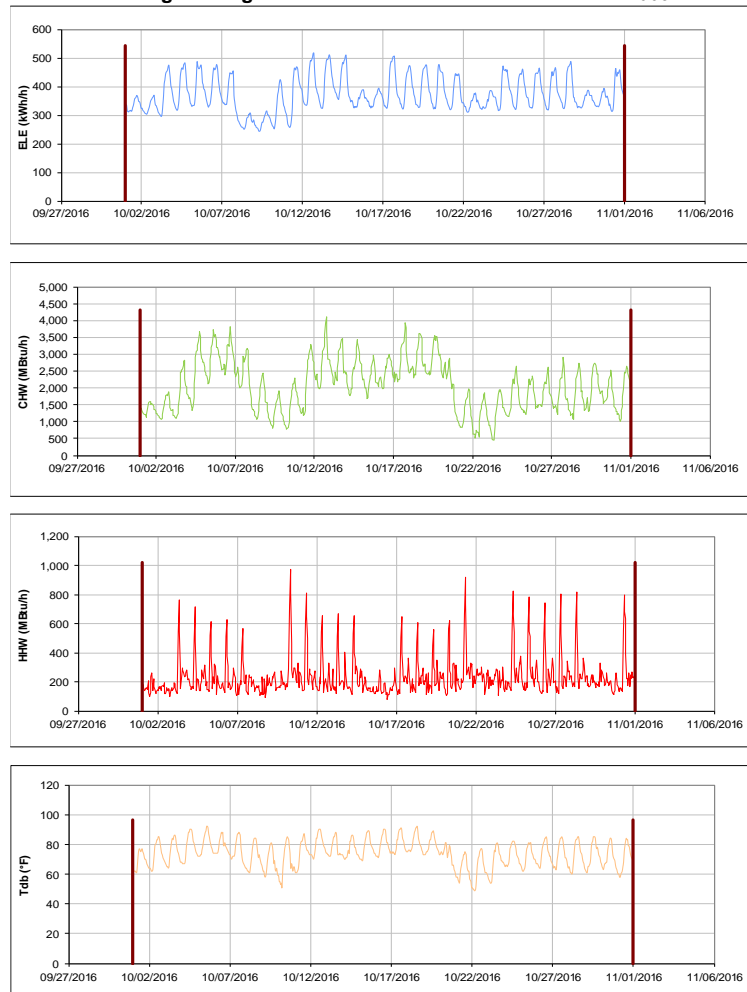
TAMU / BLDG #: 0682

Figure III-119 Hourly Whole Building Electricity, Chilled Water, and Hot Water Consumption for Wisembaker Engineering Research Center during the Month of October 2016 and the Corresponding Hourly Outdoor Dry Bulb Temperature for College Station, TX

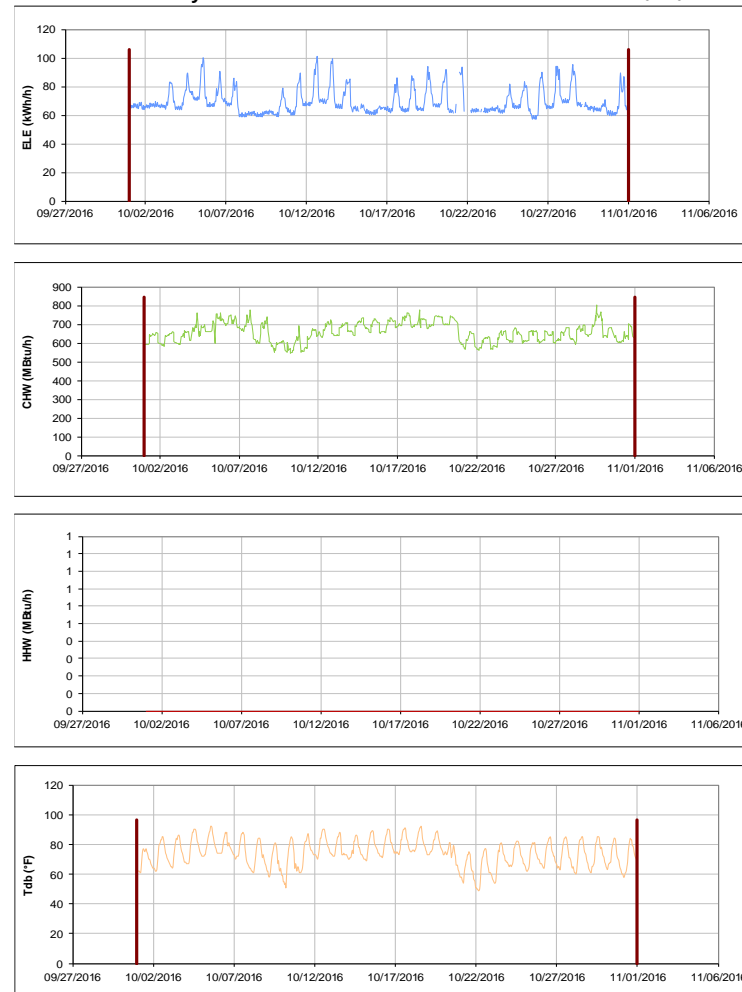
TAMU / BLDG #: 0740

Figure III-120 Hourly Whole Building Electricity, Chilled Water, and Hot Water Consumption for McNew Laboratory during the Month of October 2016 and the Corresponding Hourly Outdoor Dry Bulb Temperature for College Station, TX

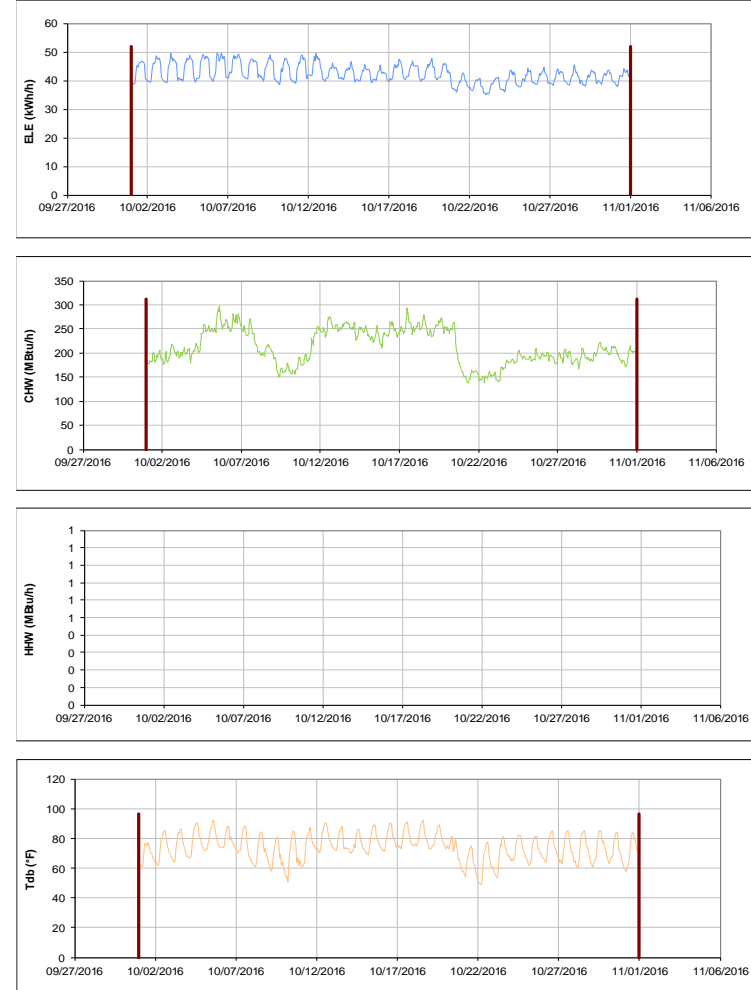
TAMU / BLDG #: 0815

Figure III-122 Hourly Whole Building Electricity, Chilled Water, and Hot Water Consumption for Entomology Research Lab during the Month of October 2016 and the Corresponding Hourly Outdoor Dry Bulb Temperature for College Station, TX

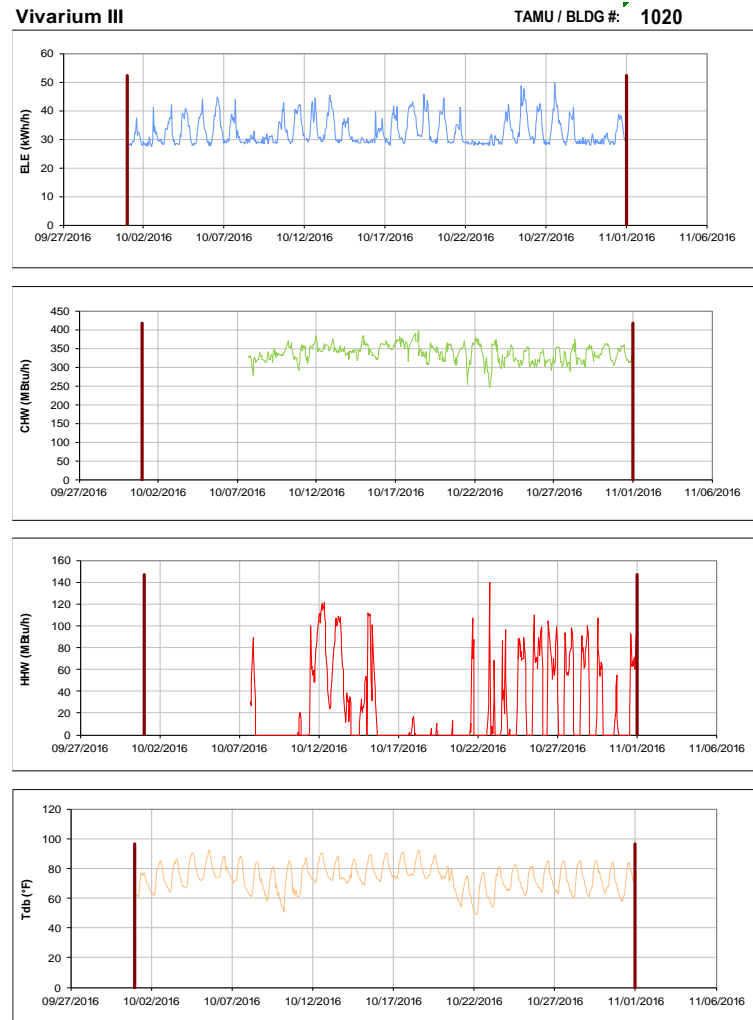
Figure III-125 Hourly Whole Building Electricity, Chilled Water, and Hot Water Consumption for Vivarium III during the Month of October 2016 and the Corresponding Hourly Outdoor Dry Bulb Temperature for College Station, TX

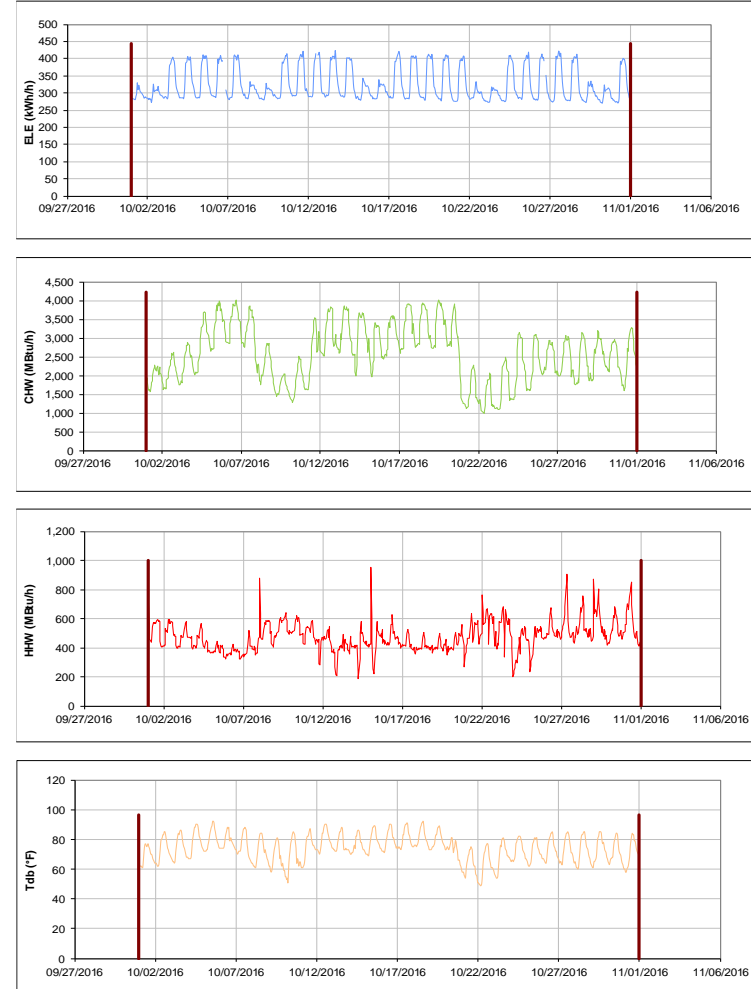
TAMU / BLDG #: 1085

Figure III-128 Hourly Whole Building Electricity, Chilled Water, and Hot Water Consumption for Veterinary Small Animal Hospital during the Month of October 2016 and the Corresponding Hourly Outdoor Dry Bulb Temperature for College Station, TX

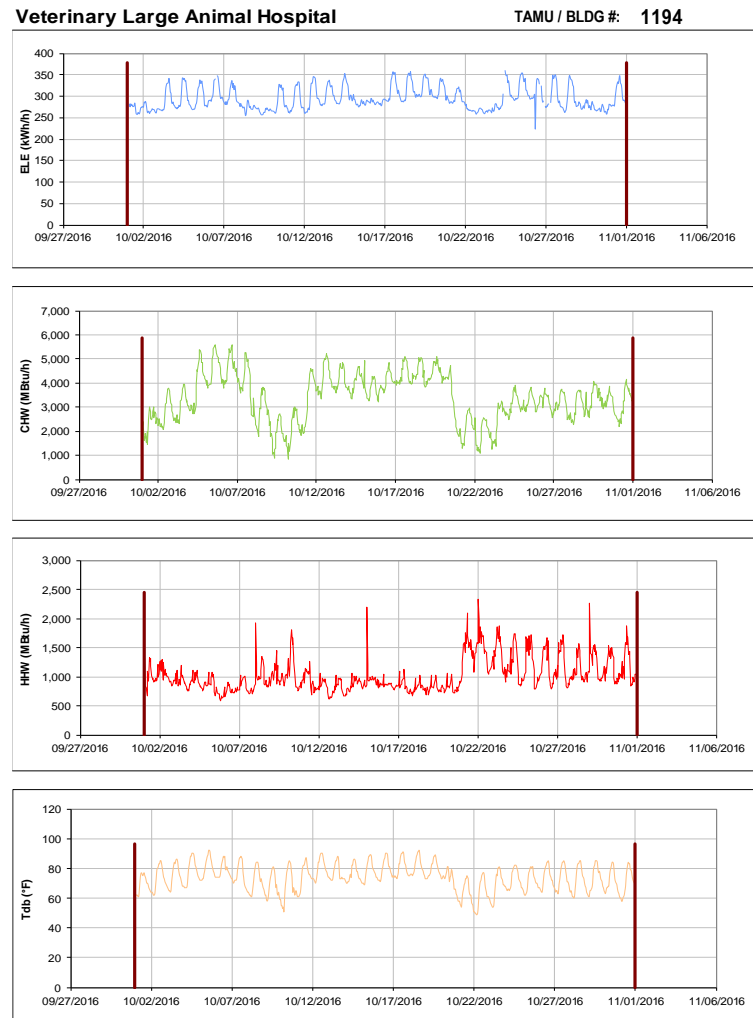
Figure III-133 Hourly Whole Building Electricity, Chilled Water, and Hot Water Consumption for Veterinary Large Animal Hospital during the Month of October 2016 and the Corresponding Hourly Outdoor Dry Bulb Temperature for College Station, TX
